# Brentwood Borough Council Local List of Non-Designated Heritage Assets

Brentwood Local List

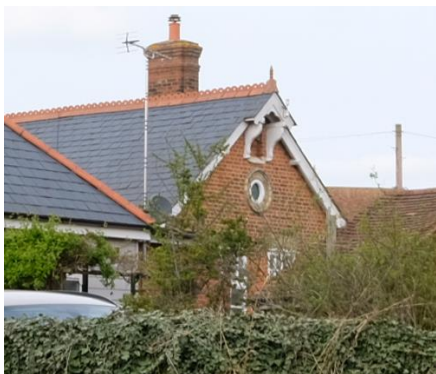
Image taken 12-4-2022			
	Clearly shown and marked 'School' on 1896 OS			
7. Description				
<p>English bond red-brick single storey building with plain gabled roof on the main range and a gabled return wing, at the rear, towards the south east. NE and SW end elevations feature white gault (or yellow) reveals curving to pointed arch brick voussoirs at the head enclosing terracotta rose and concentric circular designs above and below a central plaque that features the 1877 date on the NE elevation (absent from the SW elevation). Absent on 1873 OS the property first appears on 1896 OS. The rearmost SE gable wall features the remains of the bell-cote at the gable apex above a circular reveal: once glazed now unfortunately dominated by extraction fan. The plinth is rendered and painted</p>

from ground level to window sill around the periphery of the building. Wooden, horned sash-windows appear on the road-facing NE elevation but the gable end walls unfortunately now feature non-opening wooden mullion/transom fenestration.

It is recommended that the old school together with its walls and brick outbuildings should be preserved in any new development that might take place.

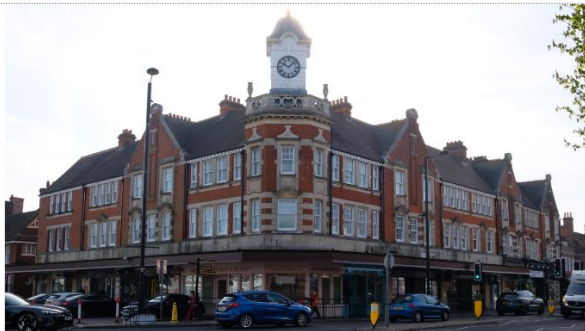
1. Name	Wilson's Corner

The prominence of the site, corner clock tower, and ornate Victorian façade detailing all present this as a significant landmark development.							
15. Archaeological Value							
To be researched.							
16. Overall Condition (insert ✓)							
Good	✓	Fair		Poor		Very Poor	
Unknown		Notes:	Local Heritage Significance deriving from this flagship retail property, reflecting substantial mid c20 commercial investment, in a building where generations of locals would have been employed. Recommended for inclusion by the CAAMP				
17. Recommended for inclusion				Yes	✓	No	
18. Date of assessment				12 April 2022

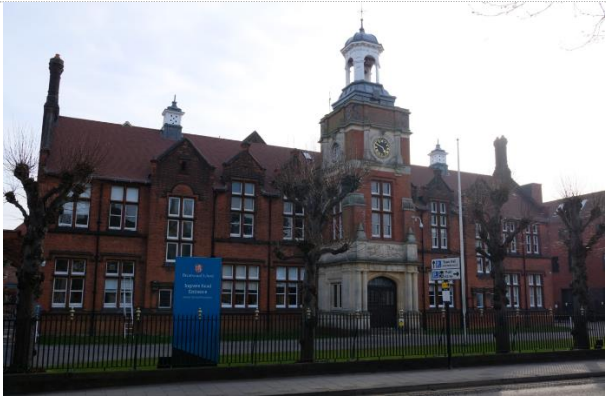
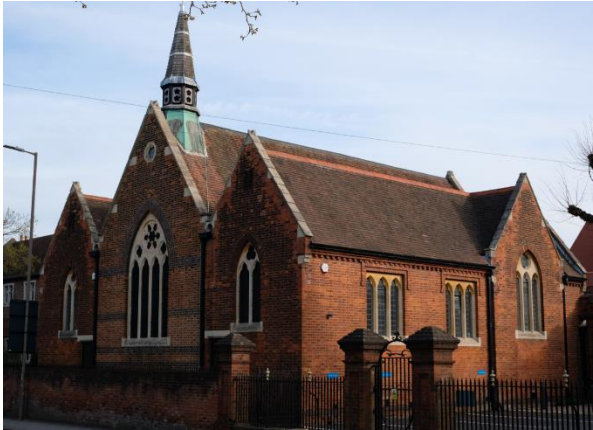
Image taken 12-4-2022

15. Archaeological Value							
To be determined							
16. Overall Condition (insert ✓)							
Good	✓	Fair		Poor		Very Poor	
Unknown		Notes:	Local heritage significance as a notable historic educational centre of characteristic architectural design by Frederick Chancellor. Recommended for inclusion on the CAAMP				
17. Recommended for inclusion				Yes	✓	No	
18. Date of assessment				12 April 2022

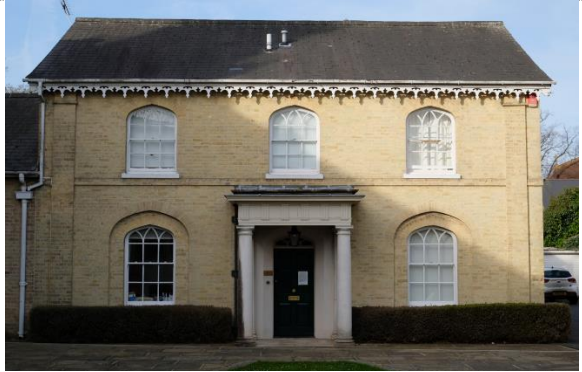
<p>Image taken 12-4-2022</p> <p>First appears on 1873 OS adjacent to the 'Orphanage'</p>

15. Archaeological Value							
16. Overall Condition (insert ✓)							
Good	✓	Fair		Poor		Very Poor	
Unknown		Notes:	Historic local heritage significance as a notable example of an institutional building serving the both ecclesiastical and educational purposes over the decades. Finely detailed Victorian styling. Recommended for inclusion on the CAAMP

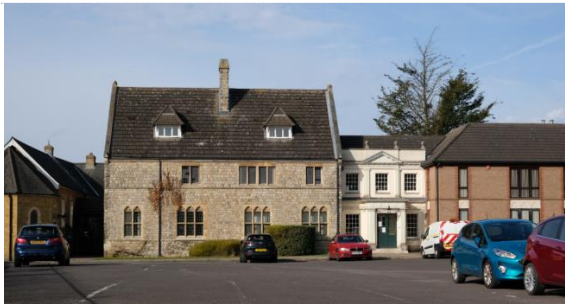
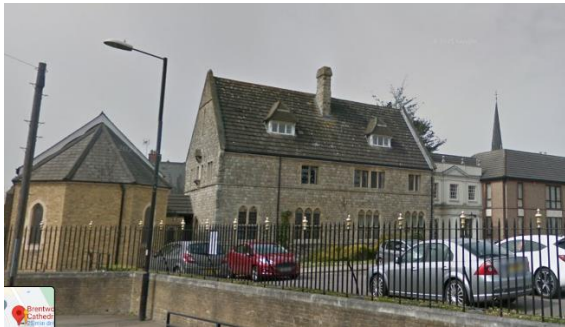
## Cathedral House

<p>GSV April 2021</p><p>Absent on 1873 OS</p><p>Clearly shown marked 'Convent' on 1896 OS south of 'Infant School'</p></div>

7. Description			
<p>Absent south of the British School showing on the 1873 OS this building first appears on the 1896 OS marked as the Convent: thereafter it becomes conjoined with the former school via the neoclassical range to form the Convent. The adjacent former school appears to have been later demolished and replaced with a modern office building housing the contemporary Cathedral House.</p> <p>A substantial two storey rectangular stone building with gable roof and attic rooms behind half-hipped gables. Ground floor fenestration with pairs or triplets of lancet windows in sandstone reveals featuring part-tracery heads. Upper storey sandstone reveals feature stone mullions and metal casements. The south gable features a small central bell-hood. Elevations are of rough-hewn faced, regularised, Kentish ragstone with discernible quoins and first floor string course.</p> <p>Between the former convent and the site of the former British School lies a white stucco neoclassical infill building with prominent porch, ionic upper storey pilasters, dentil cornice and pedimented parapet. Parapet features ball and pyramid finials. Wooden sash</p>

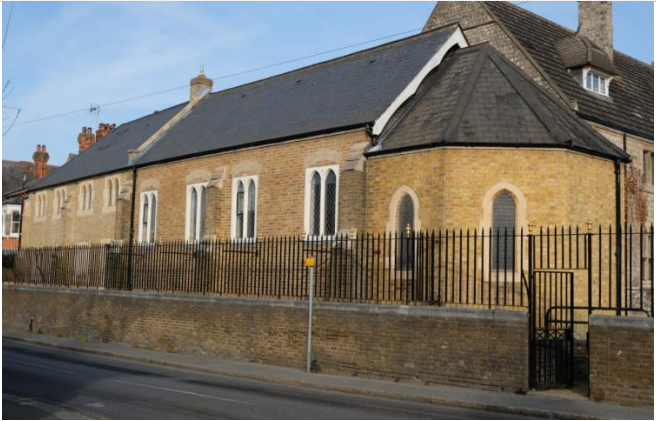
## Brentwood Cathedral Music – ‘Song School’

Clearly shown south of ‘Convent’ on 1896 OS

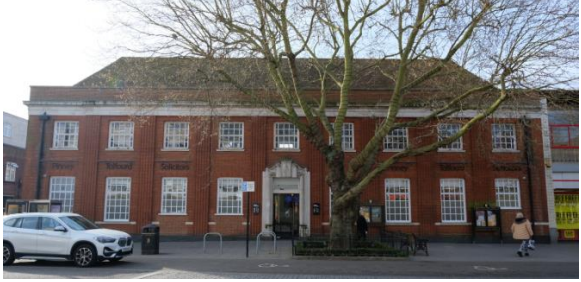
## Former Post Office

7. Description							
<p>Described in the CAAMP as '1939 large handsome brick building in the neoclassical style with metal sash windows'. A prominent two-storey brick Georgian styled building with sandstone banding cill and doorway details providing a landmark flanking the St Thomas Rd – High St junction. With a decorative, sandstone lined, central main doorway dated 1938 amidst symmetrically distributed Crittall-type fenestration.</p>

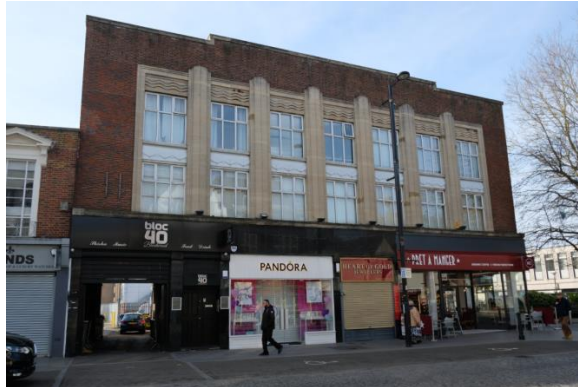
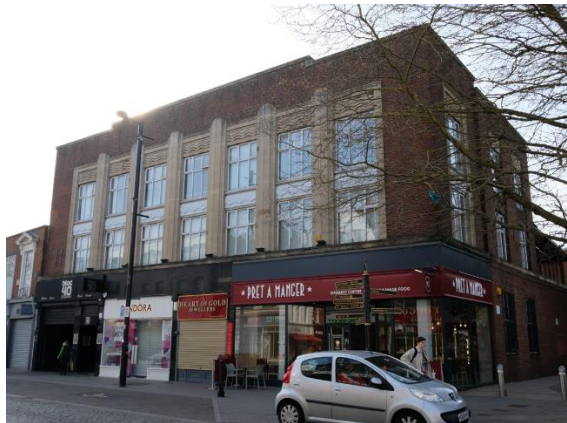
1. Name	Former Burtons Tailors' Store

7. Description					Image taken 12-4-2022
<p>Notable, three-storey former High Street tailors store on a prominent corner plot with art-deco styling to the façade. Brick facades with prominent stone pilasters punctuating the rhythmic fenestration on 1<sup>st</sup> and 2<sup>nd</sup> storeys. Spandrel panels feature interlocking triangular drapes to the 1<sup>st</sup> floor and wave-design to the 2<sup>nd</sup> floor. Carriage-arch to the rear service yard. Notable pearl-granite foundation stones celebrating the 1939 opening by Lady Montague, Arnold and Austin Burton..</p> <p>Excellent article at <a href="https://thenewwipertimes.com/2019/04/03/burtonbrentwood/">https://thenewwipertimes.com/2019/04/03/burtonbrentwood/</a></p> <p><i>Construction of the new building was carried out by George Moss &amp; Sons, Ltd., who were appointed as general contractors on both this and several other Burton stores during the late 1930's,</i></p> <p><i>...The firm's customary emerald pearl granite foundation stones are dated 1939, with those that survive laid by Arnold James Burton, Sir Montague's youngest son, Austin</i></p>					Image taken 12-4-2022

One of few Art Deco styled facades surviving in the Town. Although the ground floor fenestration has been altered from its original architecturally consistent intent, the building as a whole, celebrates pre-war optimism despite the economic hardship of the times. The carriage-arch to the eastern end of the front façade shows architectural functionality allowing service vehicles to enter the rear compound rather than block or clutter the principal façade. No original signage exists from the former Burtons Tailors' but the celebratory foundation stones provide evidence of 'topping out' the building by dignitaries indicating the previously national status of this tailoring brand and institution.

15. Archaeological Value							
To be researched							
16. Overall Condition							
Good	✓	Fair		Poor		Very Poor	
Unknown		Notes:	Contemporary storefronts currently detract from the character of the conservation area and this specific building. Recommended for inclusion on the CAAMP				
17. Recommended for inclusion				Yes	✓	No	
18. Date of assessment				12 April 2022

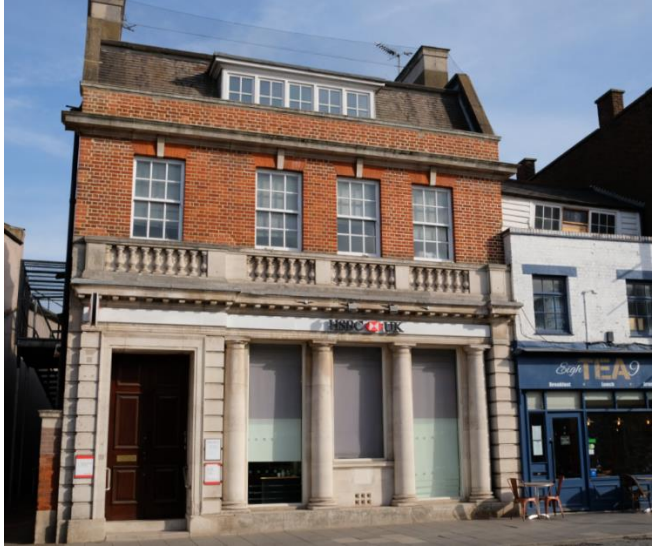
Image taken 12-4-2022

Brick-built 2 storey building with attic rooms. Ornate sandstone rusticated lower storey façade featuring four Tuscan columns and decorative sandstone balustrades to the first floor. Upper storey sash fenestration with rubbed headers and contrasting keystones beneath the sandstone cornice and parapet.

CAAMP says...**HSBC**, a former Midland Bank branch erected in 1921, is a well preserved bank building with a typically grand classical presence on the frontage, the ground floor with rusticated

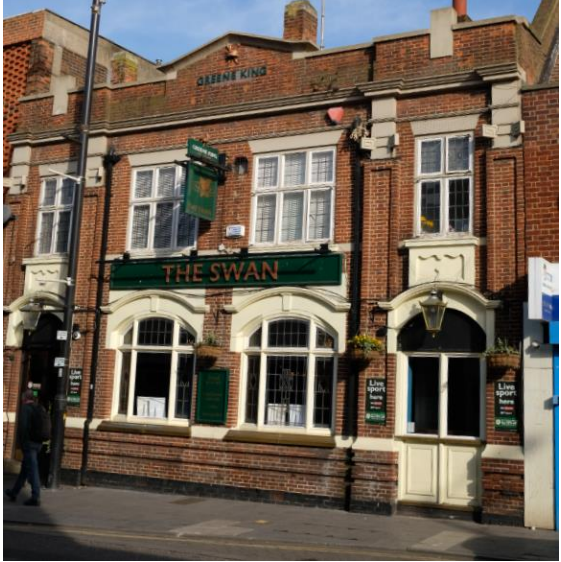
## The Swan PH

Image taken 12-4-2022							
Clearly shown as an 'Inn' on 1896 OS ... and as a 'P.H.' on 1952 OS

7. Description							
<p>Flemish-bond brick-built 2 storey Victorian style public house with a symmetrical façade balanced by 2 outermost doorways, 2 symmetrical windows, and a further outermost window, on both the upper and lower storeys. Stone (or cement bonded reconstituted stone) swept head reveals to lower storey windows, swept canopy to both doors, stone-like cills and heads, brick pilasters with stone-like capitals, brick-bands on the lower storey, and over the stone-like cornice: a pedimented parapet featuring the brewery's motif.</p> <p>CAAMP says: <b>The Swan</b> is one of the two surviving High Street public houses, rebuilt 1935 in handmade brick with flared headers. The well balanced façade has good detailing to the plinth and pilasters, and stucco window surrounds. The signage is just about under control.</p>

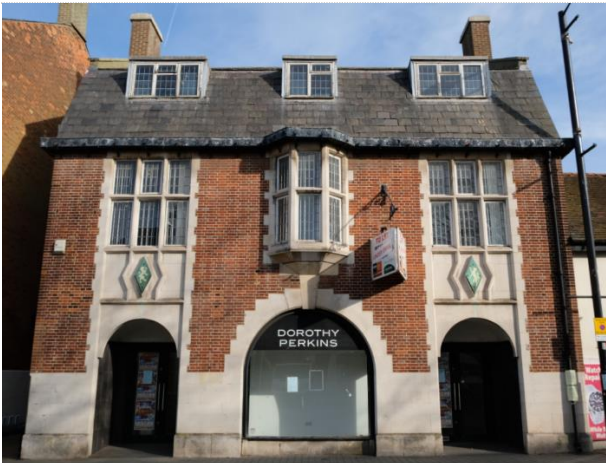
Image taken 12-4-2022			
Clearly shown as 'P.H.' on 1873 OS... and extended to the rear and labelled 'Hotel' on 1939 OS

Good	✓	Fair		Poor		Very Poor	
Unknown		Notes:	Recommended for inclusion on the CAAMP. The exact development of the structure and façade between 1873 and 1939 is unclear without further research.				
17. Recommended for inclusion				Yes	✓	No	
18. Date of assessment				March 2022

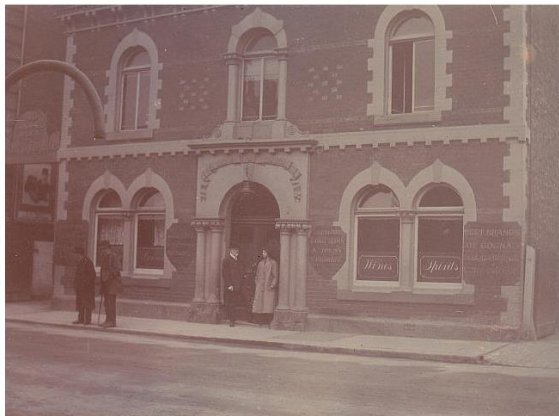
Lion & Lamb, High Street, Brentwood - circa 1910

<https://pubwiki.co.uk/EssexPubs/Brentwood/lionlamb.shtml> provides the following image of 1910 in which the front façade, whilst similarly symmetrical, differs significantly from the current.

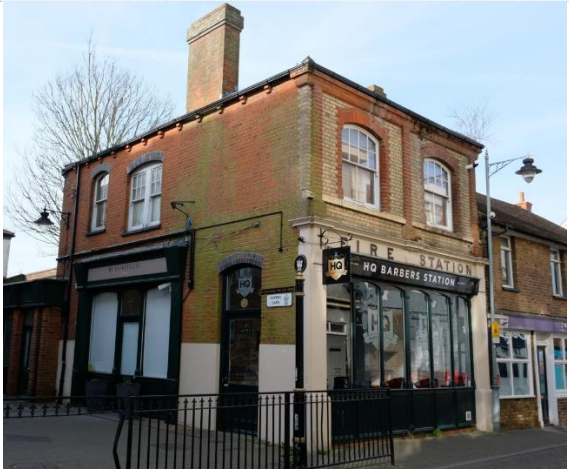
Image taken 12-4-2022

Early c20 Institutional building with clear and bold labelling on the principal elevation and evidence of large openings for vehicular access. Good evidence of an evolving fire protection strategy in the town centre soon to be replaced by much larger premises elsewhere. A great example of secular architecture – purpose evident from appearance.

12. Social / Communal Value							
13. Group Value							
14. Landmark / Townscape Value							
A remarkable bold elevation clearly seen from the public highway in Hart Street.							
15. Archaeological Value							
16. Overall Condition (insert ✓)							
Good	✓	Fair		Poor		Very Poor	
Unknown		Notes:	A remarkable building in the streetscape relatively unspoiled by contemporary modernisation. Mentioned in the CAAMP				
17. Recommended for inclusion				Yes	✓	No	
18. Date of assessment				12 April 2022

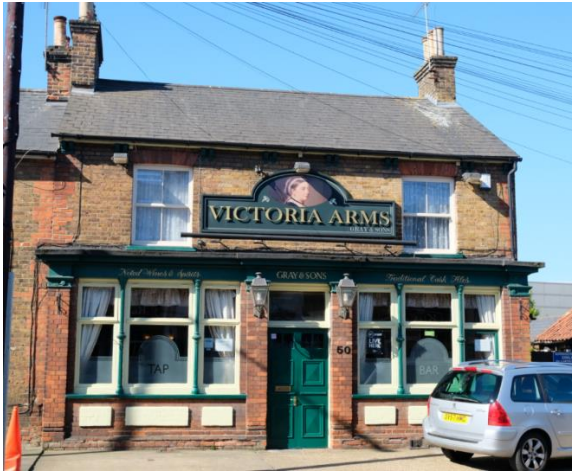
<p>Image taken 12-4-2022</p> <p>Clearly marked 'Victoria Arms (PH)' on 1873 OS Opposite 'Victoria Works (Agricultural Implements)'</p>

7. Description				
<p>A well-preserved public house featuring replacement sash windows to the upper storey and a dominant streetscape provided by traditional pre-war brewery-branded ground floor fenestration featuring original Victorian obscure-glazing. Appearing on 1873 OS across the road from the Victoria Works (Agricultural Implements) this public house was clearly associated with Victorian manufacturing furnishing agricultural industries.</p> <p>Brick-built humble dwelling with plain reveals and rubbed headers, a natural slate roof, and an adjacent yard that may have been used for transport activities. An important contributor to the streetscape.</p>

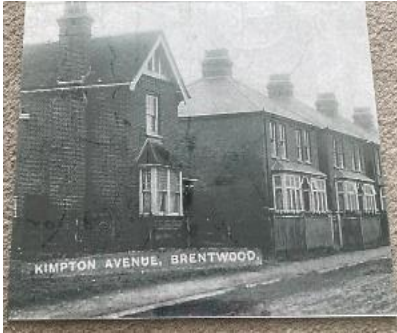
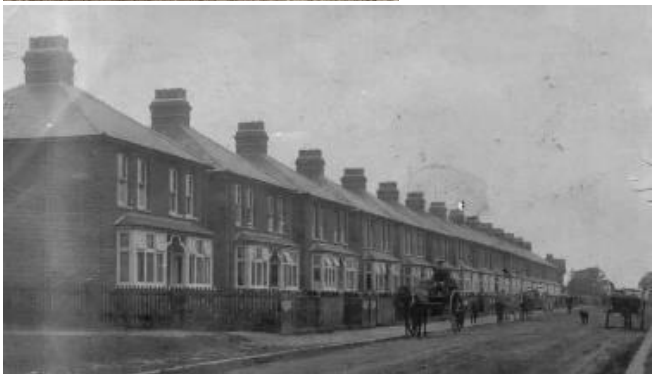
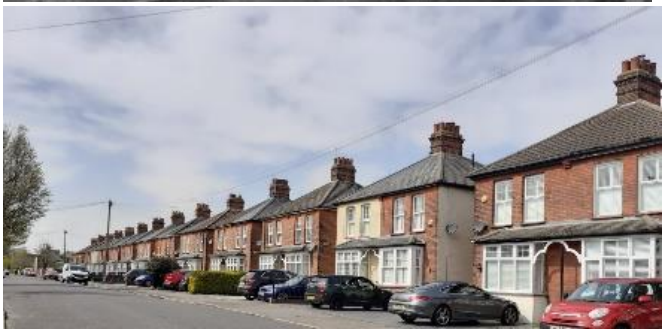
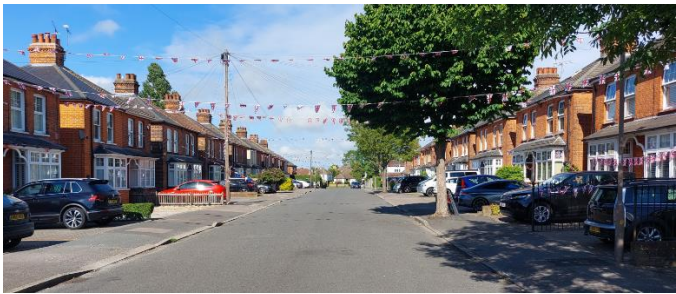
## Kimpton Avenue

Brick-built dwellings first appearing on 1920 OS, reported to be constructed in 1904 by one building company. One detached house (South side – No. 64) reputed to be the builder's residence is eastern of 30 pairs of semi-detached dwellings (Nos. 2-60). A further 32 pairs of dwellings (Nos. 1-63) are constructed to the North side of Kimpton Avenue built in a similar pattern and design. Red-brick Flemish bonded two storey dwellings with hipped roofs (originally in natural slate – now largely mostly replaced with interlocking cement-bonded tiles), central stack remains in most but not all properties, notable rectangular ground floor bay windows with canopies spanning pairs of dwellings, with decorative ogee wooden bracing. Front doors absent from the principal façade – access is primarily on the flank elevation. Red brick similar to the nearby Highwood Hospital completed in 1904. The houses are reputed to be originally 'two up two down style' with a galley kitchen and downstairs bathroom.

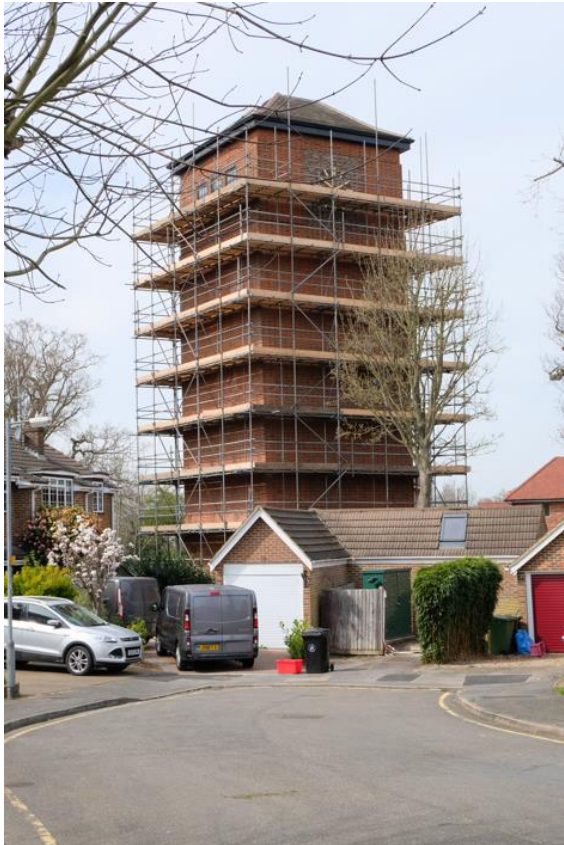
<p>Image taken 12-4-2022 viewed from The Dell</p>

1. Name	Warley Hospital clock/water tower				<p>The tower first appears on the 1960 OS</p>

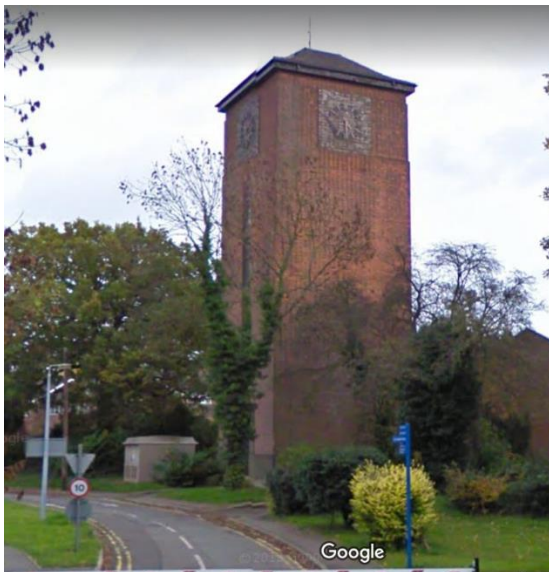
7. Description							
English bond brick-built water tower originally serving Warley Hospital now accessed via Watlington Gardens. First appears on 1960 OS. Being repurposed to residential use at time of survey.

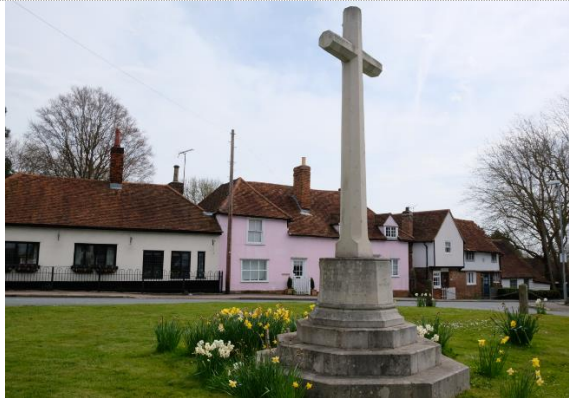
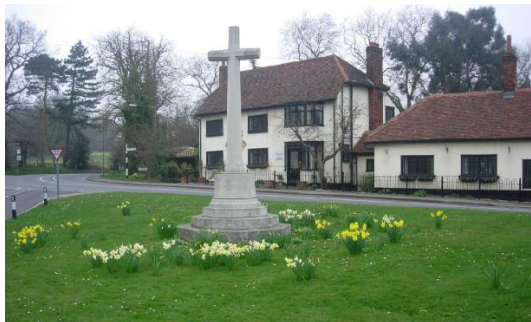
## Great Warley War Memorial

7. Description				
<p>A prominent sandstone cross set slightly back from the centre of the village green providing a landmark, and a tangible and intangible focal point.</p> <p><a href="https://www.iwm.org.uk/memorials/item/memorial/65494">https://www.iwm.org.uk/memorials/item/memorial/65494</a> provides a record updated 2018 and informs: “Cross with a carved sword on the front face. Mounted on an octagonal plinth and four step octagonal base. The names of those who died in WW1 are inscribed on four of the faces of the plinth. The North face of the plinth holds the main inscription. The horizontal surface of the top octagonal step has the names of those who died in WW2.”</p> <p>A non-designated heritage asset and important local feature currently without statutory protection other than being recorded in the Great Warley 2009 Conservation Area Appraisal and Management Plan.</p>

15. Archaeological Value							
To be researched							
16. Overall Condition							
Good	✓	Fair		Poor		Very Poor	
Unknown		Notes:	Historical and archaeological research may add further to the social value of this specific site and should be pursued.

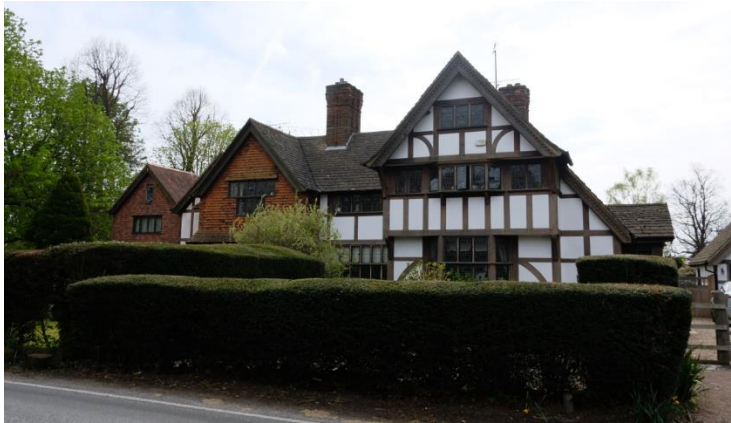
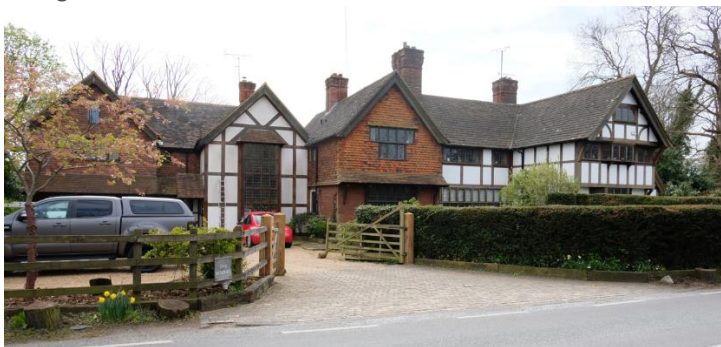
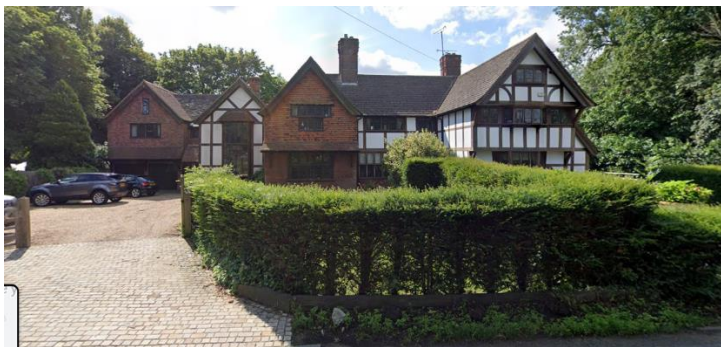
## Ruspers

GSV August 2021
				1 <sup>st</sup> shown on 1920 OS (absent on 1896 OS)
7. Description				
<p>From CAAMP ‘Ruspers: A timber-framed and tile-hung house built around 1900, in a style reminiscent of the Surrey and Sussex vernacular popularised by Sir Edwin Lutyens. In two parts, both having a main range with two cross-wings of unequal length, with gables and decorative barge boards. Windows are horizontal strips, oak framed metal casements with leaded panes. Ruspers 1 has a striking full-height single window which suggests the existence of a medieval hall within. Ruspers 2 has a west wing jettied out</p>

on two stories, each with brackets and an oriel window. The first floor windows on the main elevation continue round the corner onto the side elevation. The rear elevation has small twin gables on the main range between the wings. Both have some detrimental alterations including French windows, alien to the Arts and Crafts idiom. Another vernacular revival building, readily visible from public spaces, it is an important feature in the Conservation Area.'

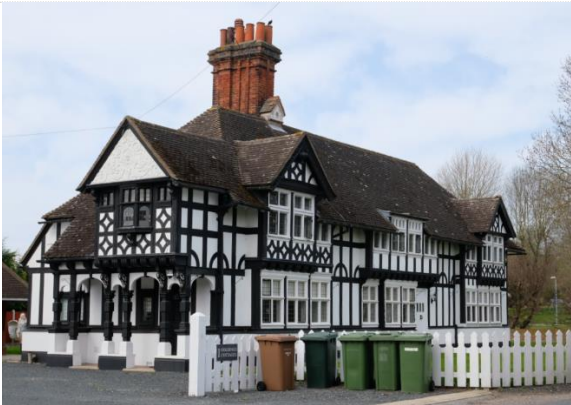
Image taken 12-4-2022

10. Aesthetic / Architectural Value							
A remarkable aesthetic treatment symbolic of stately homes such as Cheshire's Little Moreton Hall							
11. Historic Value							
Research has established the links to founding client Evelyn Hesletine and his association with Goldings (now De Rougement Hotel).

15. Archaeological Value							
Not researched							
16. Overall Condition							
Good	✓	Fair		Poor		Very Poor	
Unknown		Notes:	A remarkable late c19 building with no other heritage protection in place.

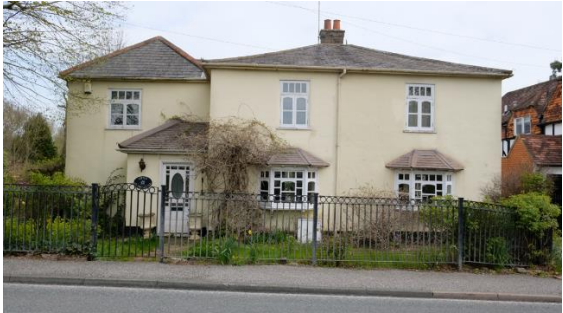
## Little Chippingdale

Present on 1860 OS – pre-dating Golding's adjacent 1896 Arts and Crafts dwellings. Modern railings are appropriately in-keeping

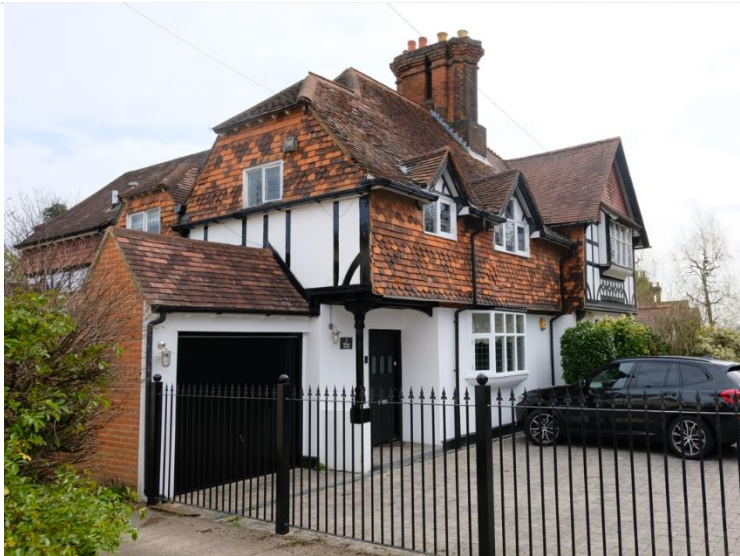
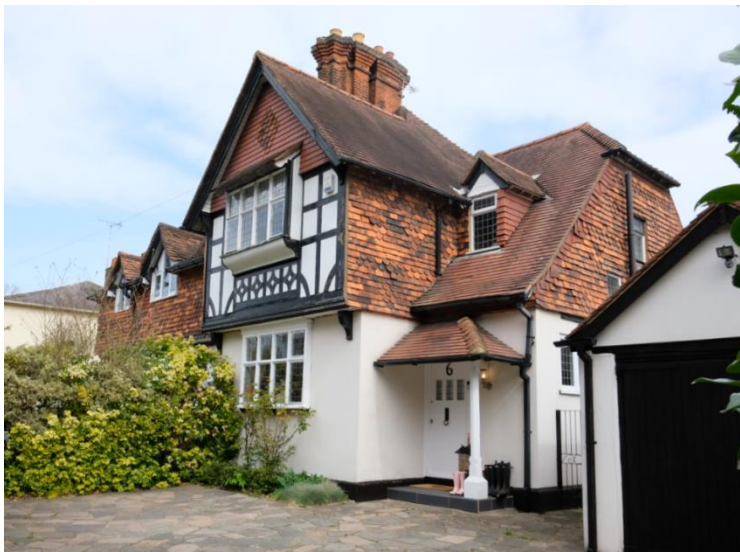
6b. If yes, which CA	Gt Warley	
7. Description		
<p>First appearing on the 1896 OS on a site previously marked as the site of a gravel pit (1860 OS), this pair of two storey semi-detached dwellings are in the arts and crafts style. With rendered lower storey and tiled upper storey and a pseudo-cross wing gabled projection to the southern end of the south-west elevation, the dwellings are dominated by the decorative black timber-boarding incorporated within the 'cross wing'. The two properties share a prominent Tudoresque stack.</p> <p>The property currently known as 'Goldings' at TQ 985 905 is a contemporary post 1950 dwelling not to be confused with the original 'Goldings' which became renamed as the De Rougement Hotel</p>

Good	✓	Fair		Poor		Very Poor	
Unknown		Notes:	Association with Sherrin to be further researched				
17. Recommended for inclusion				Yes	✓	No	
18. Date of assessment				12 April 2022

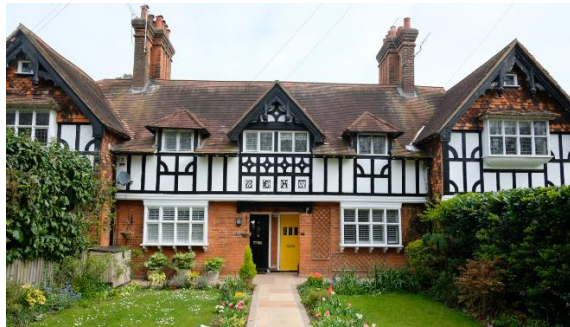
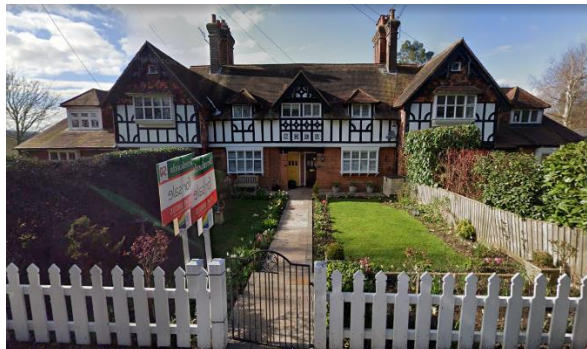
## Goldings Cottages 1-4

<p>Image taken 12-4-2022</p><p>First appearing on 1896 OS showing as four conjoined properties</p><div>

7. Description			
<p>A remarkable range of four two storey conjoined dwellings symmetrical about a central porch providing 2 doorways, protected by a gabled eave-dormer over a black-boarded white-rendered dated panel bearing '1883' and 'EH' after originating client Evelyn Hesletine as also featured on 1887 dated Golding's Lodge No 1. A symmetrically placed pair of imposing stacks adds to the rhythm provided by a pair of hipped-gable eave-dormers and pair of cross-wing like projections to the front. Larger gables feature clay wall-tiles, decorative scalloped barge boards, including pendulous (inverted) finials almost resembling hammer beam details. The upper storey is white rendered and incorporates decorative black boarding. The symmetrically placed pair of outermost doorways are relatively modest adjacent to the 'cross-wings'.</p> <p>The property currently known as 'Goldings' at TQ 985 905 is a contemporary post 1950 dwelling not to be confused with the original 'Goldings' which became renamed as the De Rougement Hotel</p>

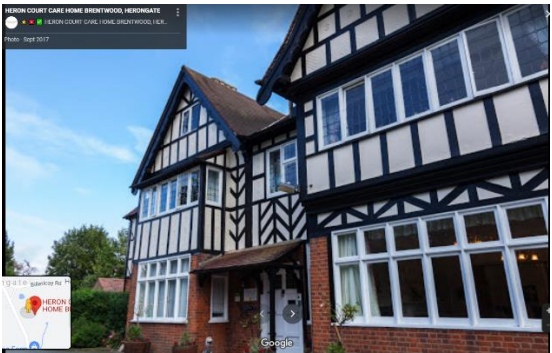
## Heron Court

<p>Building first showing on 1860 OS but appears remodelled with extension to N in 1896. Massing does not change in 1920 until post 1970 when S development added</p>
2. UID	H-HC	
3. Address	198 Brentwood Rd	
4. Postcode	CM13 3PN	
5. Grid Ref	TQ632 909	
6a. Conservation Area	Yes <input checked="" type="checkbox"/> No <input type="checkbox"/>	
6b. If yes, which CA	Herongate

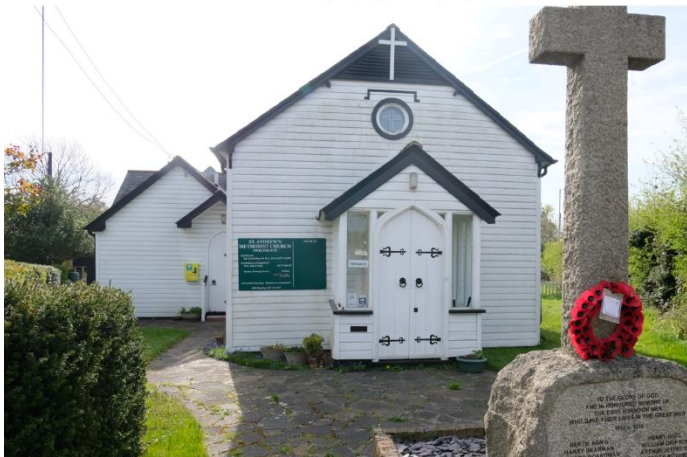
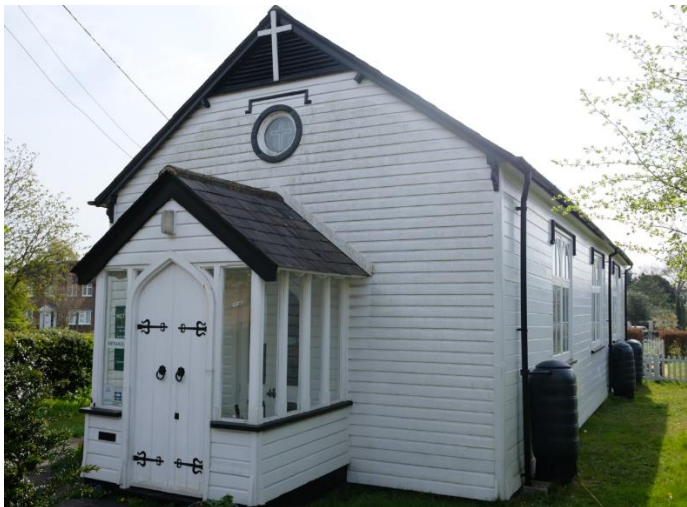
## St Andrews Church, Herongate

First shown and clearly labelled 'St. Andrews Church' on 1896 OS (absent on 1881 OS)

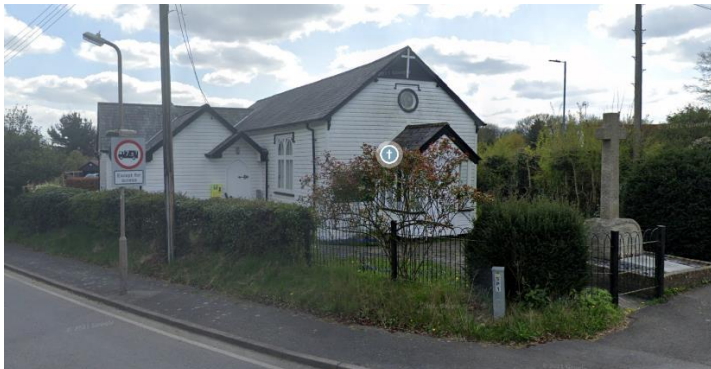
(Image from Google Streetview April 2021). Current configuration with additional range to East shown on OS since 1970					
7. Description							
A modest, single storey timber framed white, shiplap-boarded, slate roofed ecclesiastical building. First showing on the 1896 OS map and only recently being enlarged (post 1970) with an additional range to the East. Enclosed by low hedging and accommodating the War Memorial to the North, this humble building provides a notable landmark at the dominant road intersection.

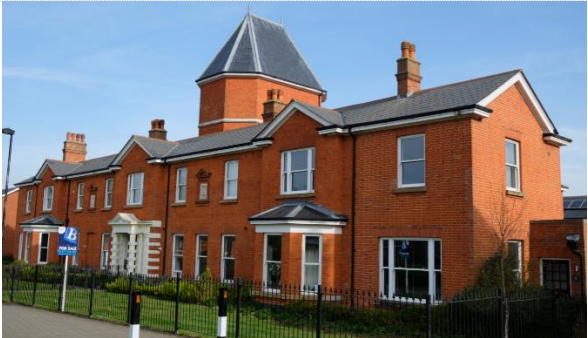
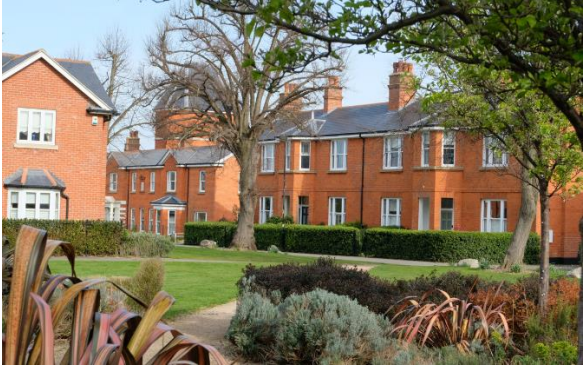
Image taken 12-4-2022

1. Name	Henman Administration Block and the Gardens immediately to its South West (West Green, Central Green and East Green)		
2. UID	HWH-AB		
3. Address	Richmond Brentwood		
4. Postcode	CM14 4SW		
5. Grid Ref	Admin TQ590944 West Green TQ59003 94446 Central Green TQ59058 94433 East Green TQ59118 94387		
6a. Conservation Area	Yes	<input checked="" type="checkbox"/>	No
6b. If yes, which CA	Highwood Hospital

Unknown		Notes:	The Admin and green spaces cannot be dissociated – they are essential components of the original hospital design.			
17. Recommended for inclusion			Yes	✓	No	
18. Date of assessment			12 April 2022

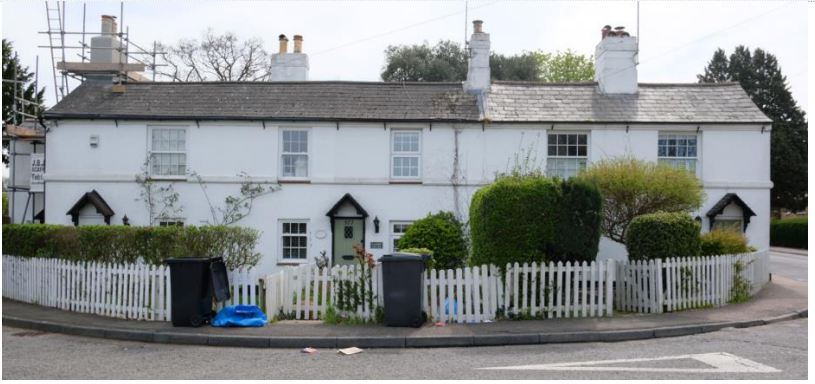
Image taken 12-4-2022

A row of four humble rendered brick-built Victorian workers cottages with regular gabled roof covered with natural slate. Brick string course visible at first floor level. Stacks remain but fenestration has been modernised with contemporary replacements. Front doors feature decorative gabled hoods.

13. Group Value							
The four conjoined properties form a group							
14. Landmark / Townscape Value							
A notable streetscape feature with its picket fencing to the front boundary adjacent to the formerly green triangle road junction at the northernmost apex of the conservation area.							
15. Archaeological Value							
16. Overall Condition (Insert ✓)							
Good	✓	Fair		Poor		Very Poor	
Unknown		Notes:					
17. Recommended for inclusion				Yes	✓	No	
18. Date of assessment				12 April 2022

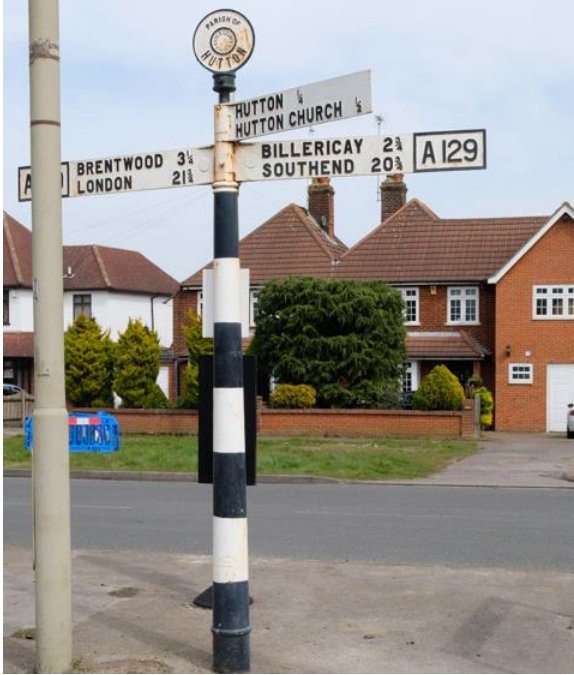
Image taken 12-4-2022

A Maldon Iron Works fabricated black and white painted cast iron guide post clearly shown on the 1896 OS. Three original guide fingers remain along with the circular Essex County Council 'Parish of Hutton' capital detail. The foundry marks are still visible on the guide-fingers but closer inspection is required to decipher the origin. '*Maldon Iron Works*' makers mark clearly visible on post approx. 0.5m from ground level.

One of few remaining cast iron posts with expressed lettering and distinctive capitalised font and fractional mileages							
11. Historic Value							
Clearly shown on the 1896 OS							
12. Social / Communal Value							
13. Group Value							
14. Landmark / Townscape Value							
Clearly visible feature of the public highway							
15. Archaeological Value							
16. Overall Condition (Insert ✓)							
Good		Fair	✓	Poor		Very Poor	
Unknown		Notes:	If unprotected by local listing these historic guideposts could be removed by highways contractors without notice and their loss would be to the detriment of the historic character of the conservation area.				
17. Recommended for inclusion				Yes	✓	No	
18. Date of assessment				12 April 2022

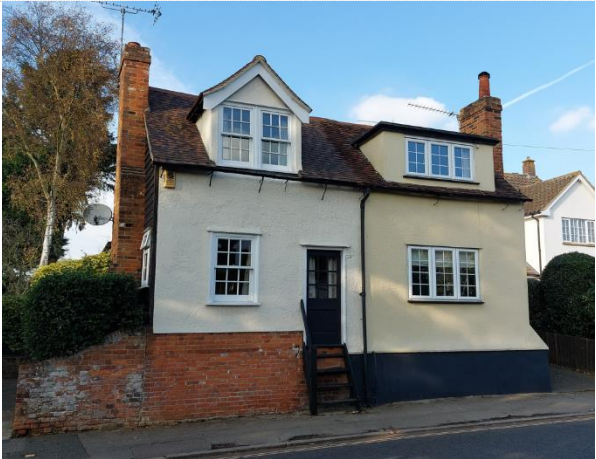
Image taken 16-11-2021

Modest dwellings with appropriately rendered facades over original brickwork (no 14) and retained stacks provide evidence of historic residential properties along this important London-Colchester highway. Visible brick plinth between footway and rendered façade of No.14 with suspended boot-scraper and wooden steps to front door provide important evidence of historic setting adjacent to the highway that has become eroded by decades of wear and remodelling.

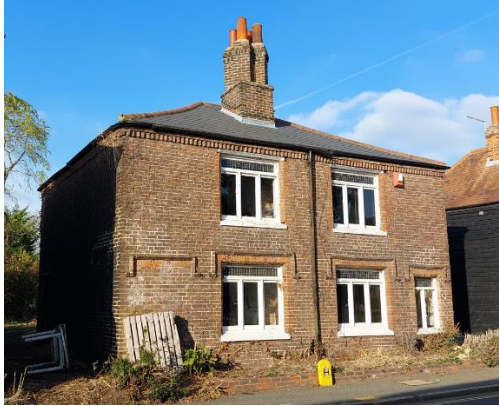
2. UID	IHS24			
3. Address	24 High Street			
4. Postcode	CM4 9EE			
5. Grid Ref	TQ 652 997			
6a. Conservation Area	Yes	<input checked="" type="checkbox"/>	No	
6b. If yes, which CA	Ingatestone High Street			
7. Description				
<p>Evidently previously two semi-detached dwellings with doors to front façade now bricked-up and frames removed but still evident. Interesting label (hood) mouldings, once fine rubbed headers over door and window reveals, fine multipane leaded ?victorian broad fanlights, (?) pseudo-c16 central stack. As brick dentil course under eaves, slate roofing (now Eternit type) and brick construction (rather than TF). Probably 'mock tudor' Victorian.</p> <p>Present on 1896 OS 1st edition. – indistinct on Chapman &amp; Andre 1777</p>

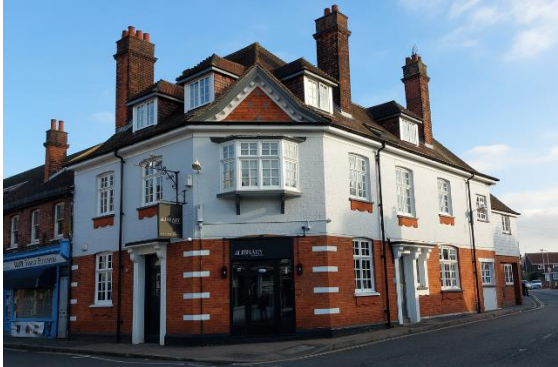
Image taken 16-11-2021

Current regular floor plan and truncated return seen on 1920 OS map replaces earlier plan shown on 1896 2nd ed OS where return is acute and Stock Lane façade is staggered in 3 bays along lane. Flemish bond red brick painted over first floor level. Swept heads over windows and interesting fine rubbed bwk skirts under plain (stone?) cills. Decorative stone or cementitious wall plate banding either side of corner doorway.

Positive but of lower significance. Current building likely to be a 1920s replacement shown by sudden appearance of the truncated return and corner doorway on 1920s OS map.

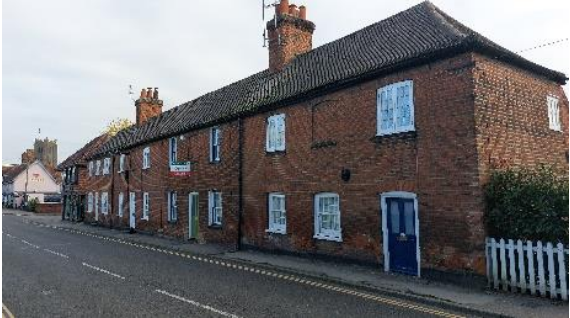
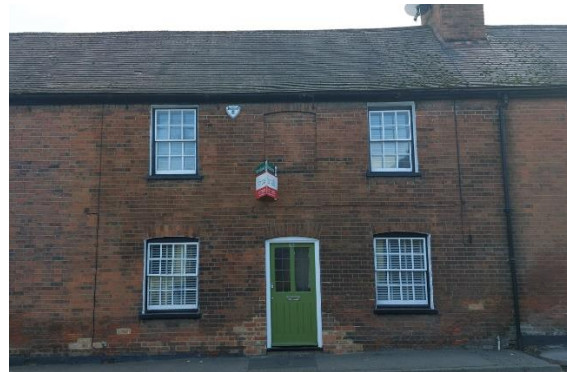
Image taken 16 -11-2021

No63 with original fenestration

10. Aesthetic / Architectural Value							
The continuity and condition of the soft Essex red bricks together with the regular rhythm of the fenestration across these four dwellings provides character to the conservation area.

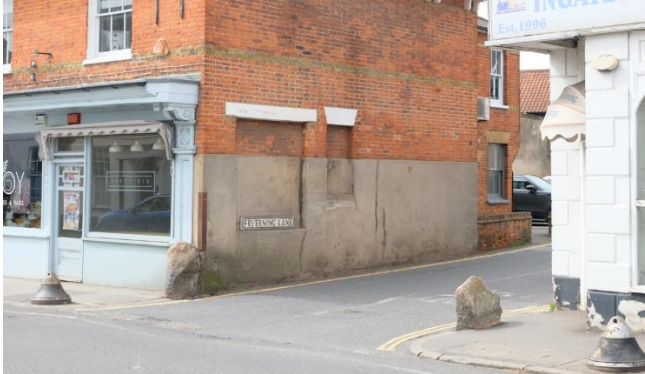
<p>Image taken 12-4-2022</p>

Good		Fair	✓	Poor		Very Poor	
Unknown		Notes:					
17. Recommended for inclusion				Yes	✓	No	
18. Date of assessment				16-11-2021

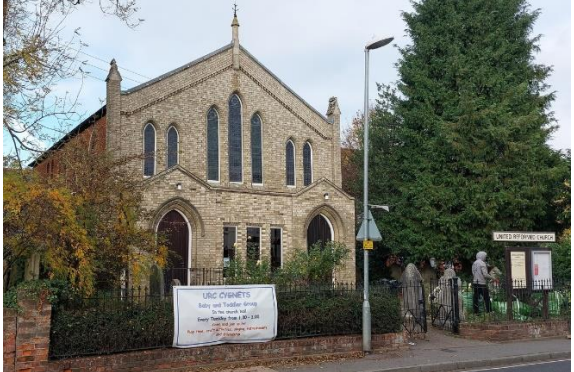
Image taken 16-11-2021

Clearly shown on the 1873 OS 'Congregational Chap' [sic]

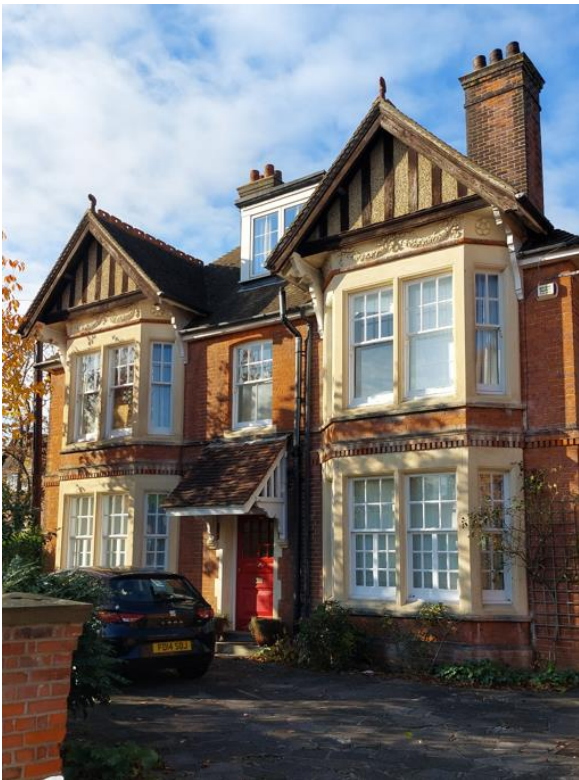
<p>Image taken 12-4-2022</p>				
7. Description				
Unmistakably Victorian architecture with two storey bay windows symmetrically placed around the central front doorway. Dentil stringcourse at first floor level and decorative foliage swags and tudor roses on the frieze over the upper storey bay windows. Ornate wooden console brackets support the projecting bay gables. Main roof hipped gable of plain clay tile between imposing symmetrically placed twin stacks. Later inserted attic

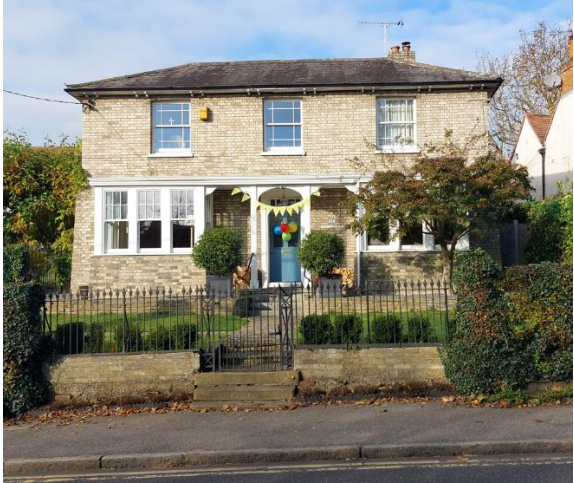
Image taken 12-4-2022

7. Description			
<p>A fine symmetrical two-storey white Flemish bonded gault brick-built dwelling. Hipped roof of natural slate with symmetrical flat-roofed lower storey bay windows, linked by canopy supported by wooden posts, protecting the centrally placed front doorway. Upper storey margin-glazed fenestration between plain brick reveals. Lower storey six-over-one sliding sashes. Set back from the highway with wrought iron railings/gate and hedging to roadway verge.</p>

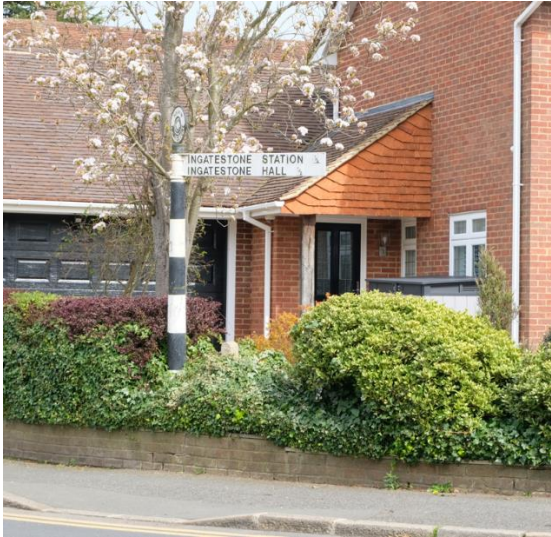
An original cast iron guide post made by Maldon Ironworks (founded 1833) featuring fractional imperial mileage to Ingatestone Station and Ingatestone Hall. Not marked on OS until 1960 but other similar examples in Herongate for e.g. feature in 1873 OS. Expected to be installed soon after the 1843 construction of the railway station.

Maldon Ironworks was founded in 1833 moved in 1875 and was an active foundry until it was converted to a radio workshop in 1955.

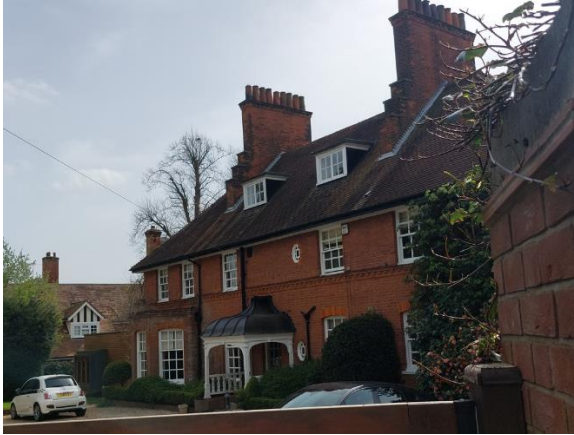
5. Grid Ref	TQ 647 991			
6a. Conservation Area	Yes	No		
6b. If yes, which CA	Ingatestone High Street			Image taken 12-4-2022
7. Description				
<p>Partly obscured from public highway. A substantial two storey red-brick dwelling with attic rooms. Six over six sliding sashes to the upper and storey except on the ground floor six-over-nine bay window at the southern end of the principal elevation. Soft-rubbed headers to lower storey reveals, brick dentil string course at first floor level. Central leaded canopy protects the main doorway flanked by lunette reveals lower and upper storey. A pair of impressive stacks each support nine flues with pots.</p> <p>The CAAMP provides 'The Red House is a Sherrin house of red brick in a Queen Anne Revival style with distinctive ogee-shaped roofs on the porches. The house is obscured from view behind rather imposing modern walling and gates (Fig. 29). It is known locally for being the former home of the suffragettes Madeline and Dorothy Rock (Wilde 1913, 319).'</p>

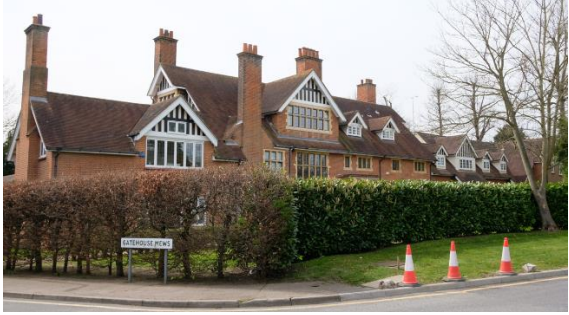
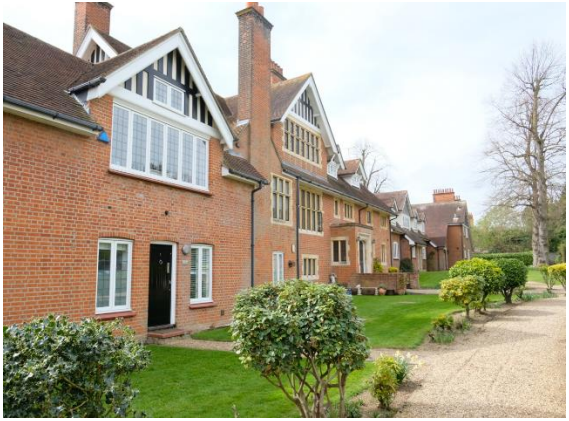
2. UID	ISL-GH											
3. Address	The Gate House Station Lane Ingatestone											
4. Postcode	CM4 0BL											
5. Grid Ref	TQ 648 991											
6a. Conservation Area	Yes	<input checked="" type="checkbox"/>	No									
6b. If yes, which CA	Ingatestone Station Lane											
7. Description  <p>The principal elevation is obscured from the public highway by a high, impenetrable hedge. Extended to the south, the original three storey Flemish-bonded red brick-built dwelling to the north end of the main elevation features sandstone mullion/transom fenestration with matching reveals. An offset front doorway is protected by a brick-built stone detailed porch. At the southern end, the third storey is partly in a prominent timber-boarded gable, and partly with a pair of gabled dormers.</p> <p>The CAAMP provides: 'The Gate House was Sherrin's own house, built in 1884, now extended and converted into several separate apartments (Fig. 30). It is a notable building in the conservation area, although unlisted. The house was built to face towards the lake, and the Station Lane elevation was in fact the rear. Following a campaign by the Victorian Society it was extensively restored in the 1980s having been derelict for some time.;</p>												
8. Age (Insert <input type="checkbox"/> ) <table border="1"> <tr> <td>Pre-1840</td> <td></td> <td>1840-1913</td> <td><input checked="" type="checkbox"/></td> <td>1914-1947</td> <td></td> <td>Post 1947</td> <td></td> </tr> </table>					Pre-1840		1840-1913	<input checked="" type="checkbox"/>	1914-1947		Post 1947	
Pre-1840		1840-1913	<input checked="" type="checkbox"/>	1914-1947		Post 1947

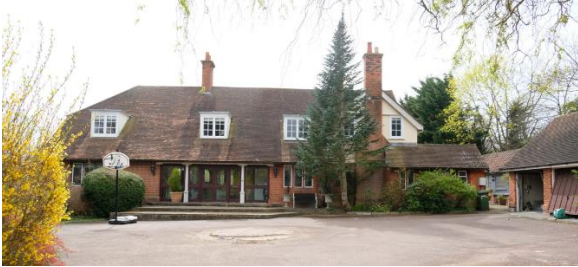
Image taken 12-4-2022

7. Description							
<p>Considerably altered since it first appeared on the 1896 OS. Now presented as a chalet style dwelling with attic rooms. English bonded red brick lower storey with large area of plain tiled roof dominating the upper storey of the principal façade. Porch features glazed curtainwall with two timber posts supporting the eaves of the main roof.</p>

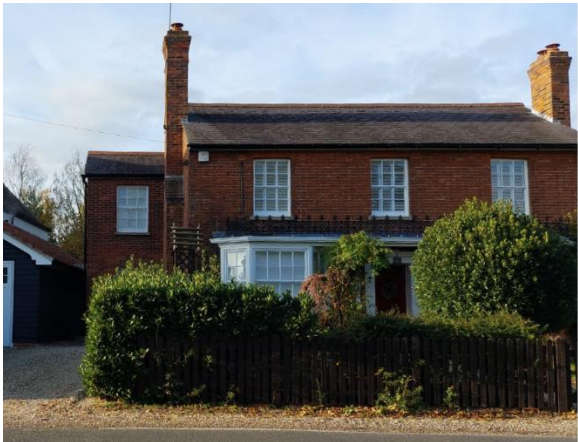
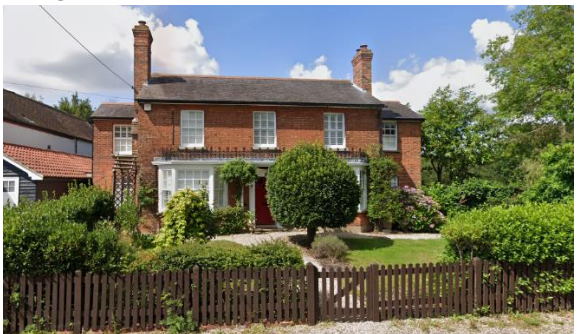
<p>Image taken 12-4-2022</p>

7. Description				
<p>CAAMP provides: <b>The Bays</b>, formerly Bay Cottage, is another 19th-century house similar in size and style to Hill House, but of red brick and less enlarged. A cast iron parapet fronts the roof that runs across the façade over the two ground floor bay windows. There are extensions on each side, but well set back mitigating their impact on the appearance of the house. The front garden is enclosed by a plain wood picket fence and hedge, continued to the east by a wattle fence which contains the garden to the side where there is a large pond, largely invisible from the road, and presumably of historic origin, once associated with the Hall and its farmyard. The fence is set back from the road edge, following the line of a strip of former manorial waste, a relict survival of the historic landscape.</p>
