# Brentwood Borough Council Local List of Non-Designated Heritage Assets

Brentwood Local List

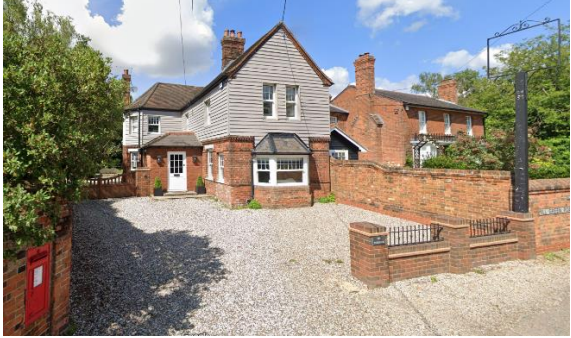
<p>GSV 31-5-2022</p>

7. Description							
<p>Strangely end-on to the public highway with a projecting bay to the south as shown on the 1896- OS. Brick-built two storey dwelling with Flemish bonding brickwork to the lower storey, dentil brick string course at first floor level, decorative Catherine-wheel terracotta inserts; painted weatherboarding throughout the upper storey. Replacement windows since residential conversion from public house. Remains of the roadside pub sign still remain.</p>

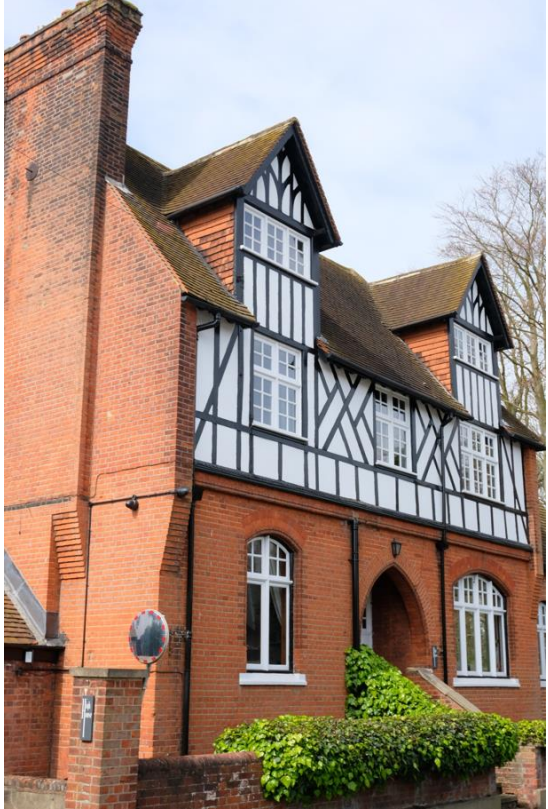
7. Description
An imposing red-brick three storey dwelling featuring high stacks with overhanging brick details, plant-on Chinese Chippendale boarding to the upper storeys, swept headers and attic rooms in gabled dormers: arts and crafts style. Impressive double fronted primary elevation symmetrical about the central pointed-arch porch. A dominant contributor to the streetscape. First shown on the 1873 Ordnance Survey

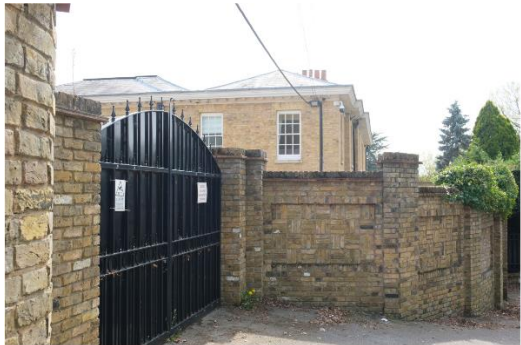
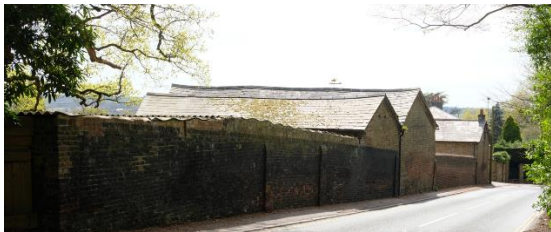
## Weald Hall

Image taken 12-4-2022

Good	✓	Fair		Poor		Very Poor	
Unknown		Notes:	A historic property currently with no other heritage protection				
17. Recommended for inclusion				Yes	✓	No	
18. Date of assessment				12 April 2022

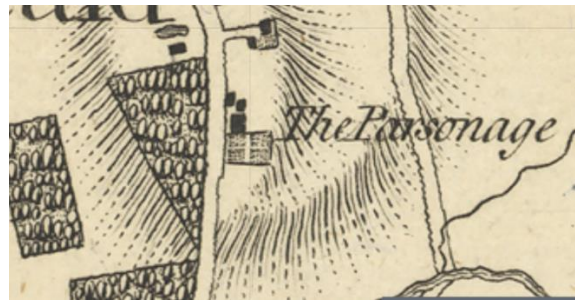
Marked as 'The Parsonage' on Chapman and Andre 1777

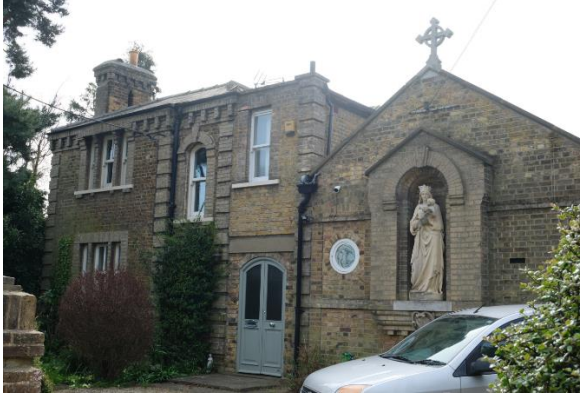
## Thorndon Gate House

Image taken 12-4-2022

The property is clearly shown on the 1873 OS as 'School (girls)'. It is marked as 'School' on the 1939 OS but not so on the 1960 survey.

Entitled 'Thorndon Gatehouse': A remarkable English-bonded brick-built two-storey building of modest proportions with rusticated brick quoins, heavy dentil eave course, and an adjacent chapel. Marked 'School (girls)' on 1873 OS and as 'School' on 1939 OS, the property is now in residential use and a flat-roofed two-storey extension to the west now joins the chapel to the main property via an entrance way. Main structure and chapel both feature natural slate roof coverings. Tripartite and round-arch sliding sash fenestration with brick reveals are prominent features. The rooftop cruciform, and Mary and Christ figure within a brick niche on the North elevation of the chapel, are prominent ecclesiastical features. The historical use of the building, its architectural styling and prominent detailing contribute to heritage significance and streetscape.

15. Archaeological Value							
Not researched							
16. Overall Condition (insert ✓)							
Good	✓	Fair		Poor		Very Poor	
Unknown		Notes:	The historical use of the building, its architectural styling and prominent detailing contribute to local heritage significance
